# Marble Falls Whitman Branch Watershed

## WHITMAN BRANCH FINDINGS

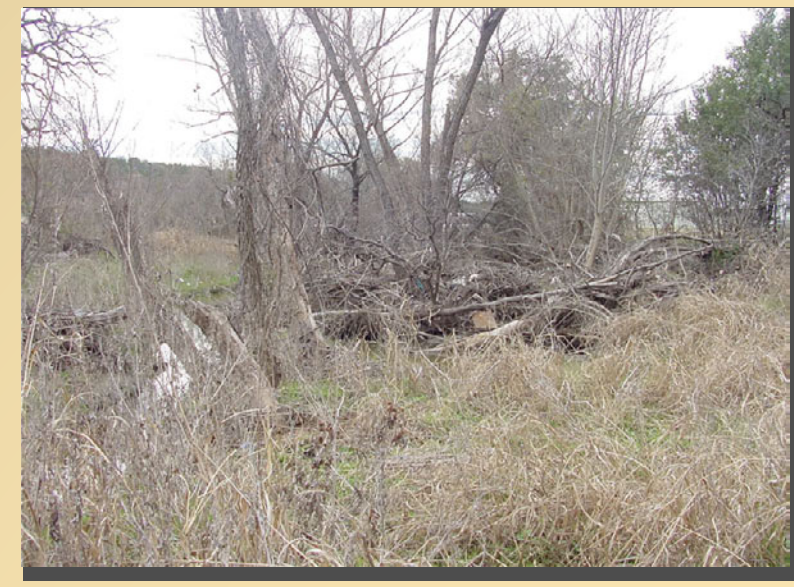
Photo 35. Looking downstream of Commerce Street, overgrown with willows, debris jams, poorly defined channel.

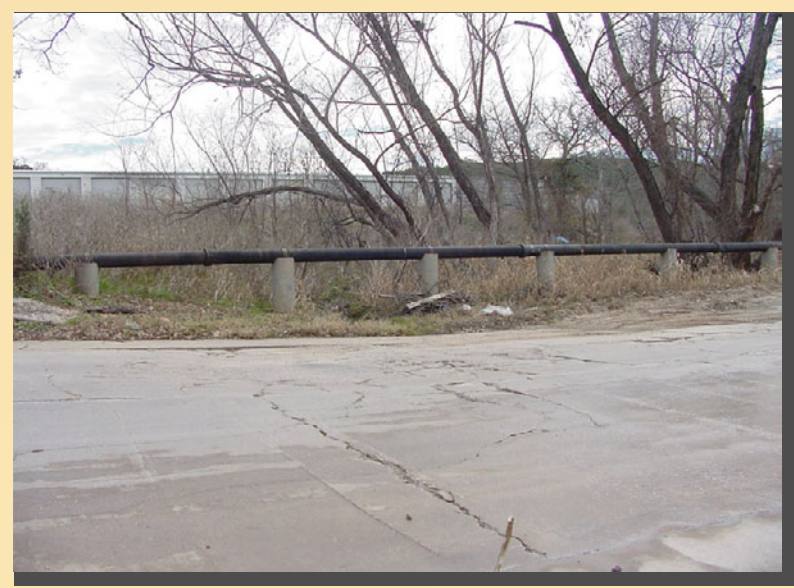
Photo 36. Commerce Street, elevated wastewater line on downstream side of street.

From West Oak Ridge Drive to near Coach Drive, the creek is significantly impacted by commercial and industrial activities that have channeled the creek and encroached into the floodplain. Trash, flood debris, and creek bank erosion are prevalent throughout this creek segment. An elevated wastewater line crosses the creek at Commerce Street and runs parallel to Commerce Street.

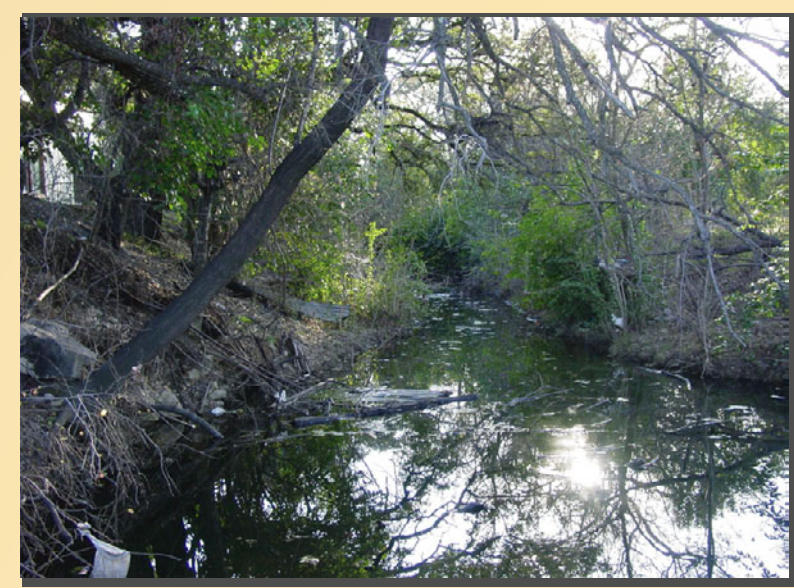
Photo 24. At Highway 281, looking downstream at debris and trash.

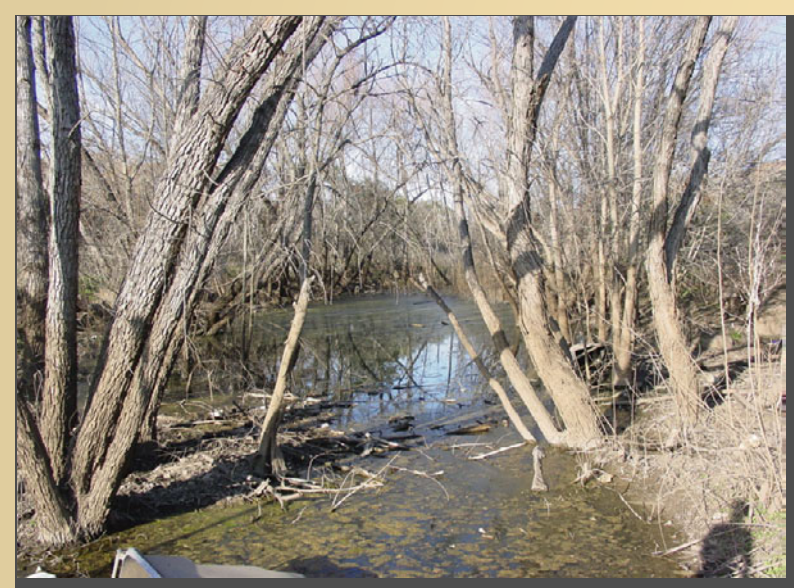
Photo 19. Looking upstream at stagnant water area above Mission Hill Drive.

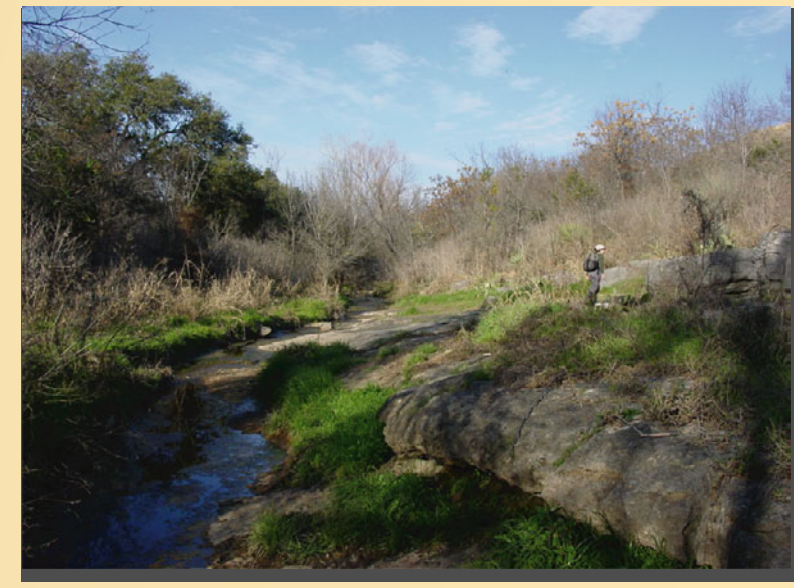
Photo 20. Upstream of Mission Hill Drive, looking upstream, good hike/bike trail potential.

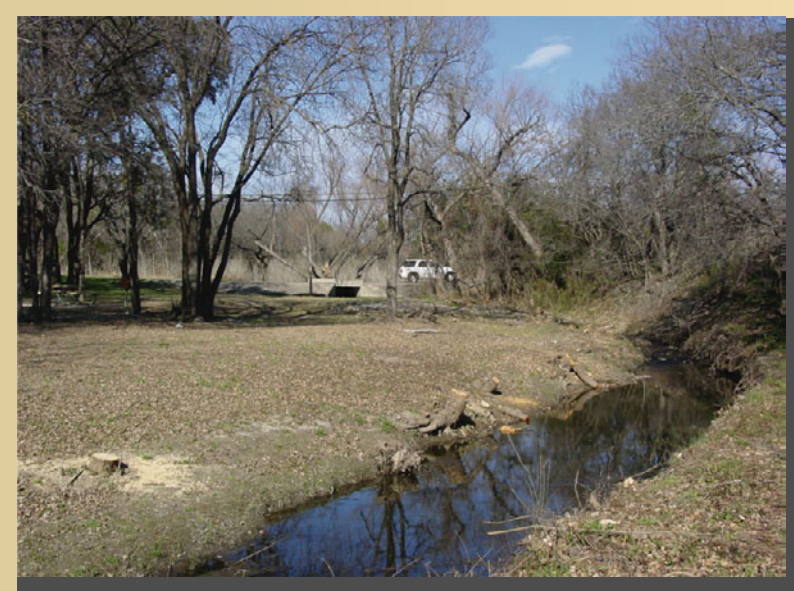
Photo 13. Looking upstream at Broadway Street. Recent tree management by city crews.

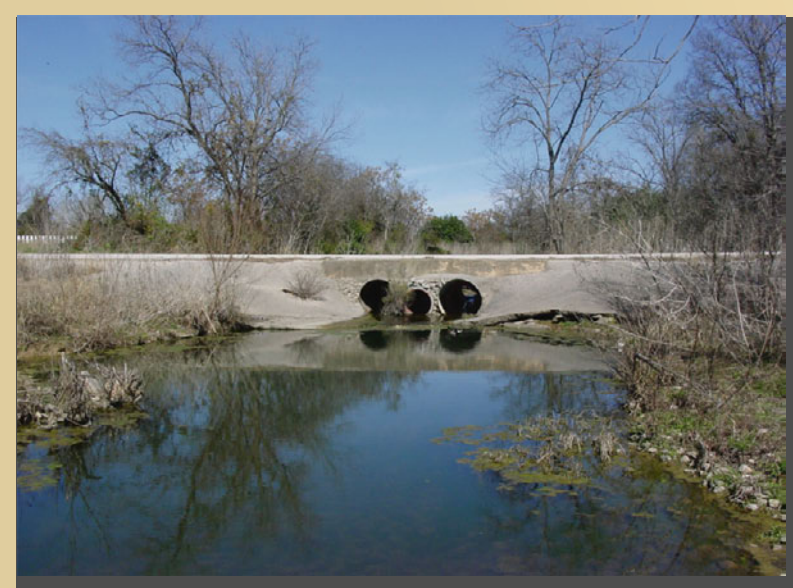
Photo 4. Looking upstream at Yett Street, scour hole approximately 4 feet deep, concrete rip rap failing.

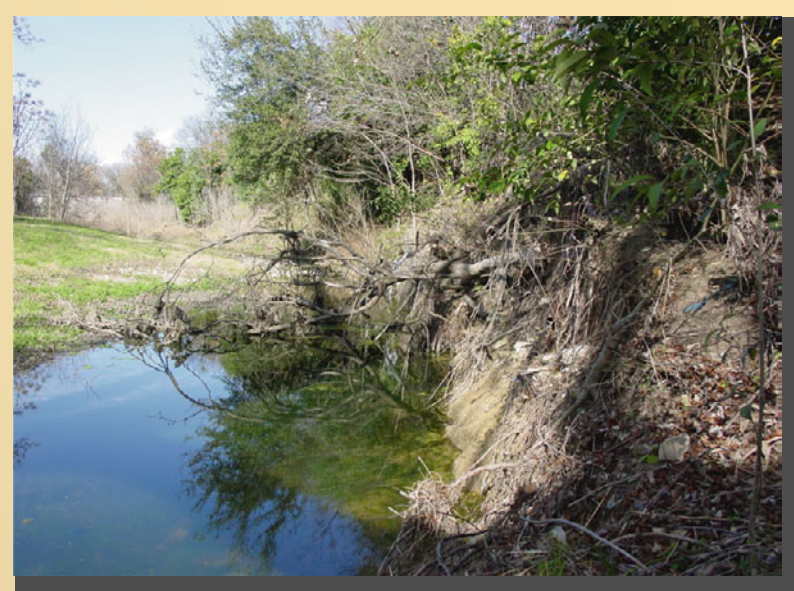
Photo 8. Fallen trees upstream of Third Street.

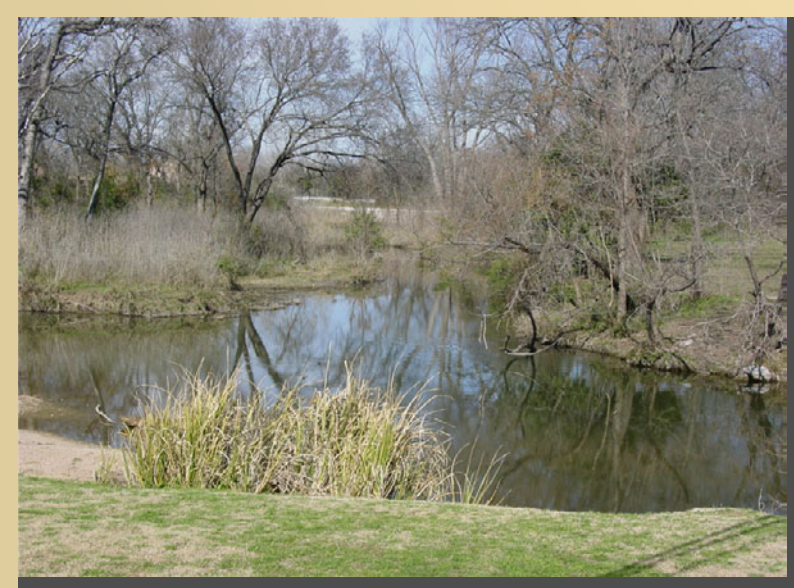
Photo 1. Whitman Branch at Backbone Creek confluence looking upstream at Whitman Branch.

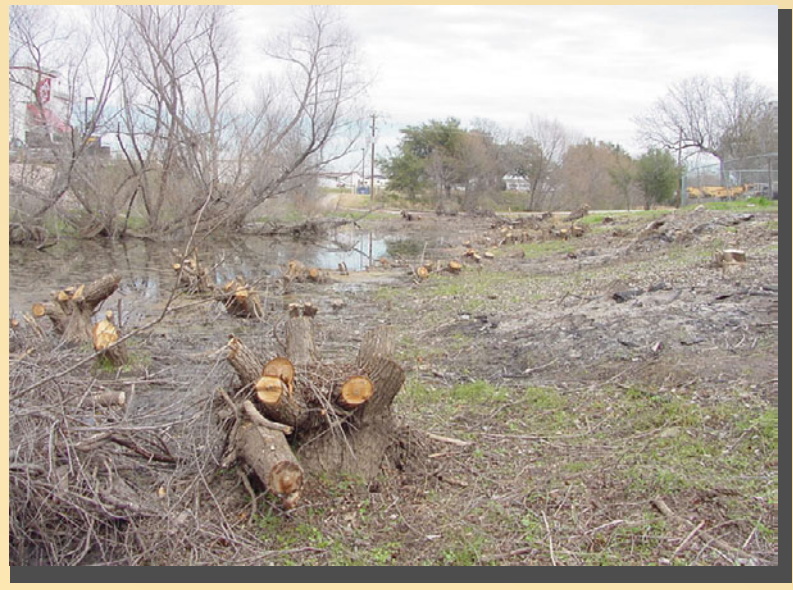
Photo 38. Looking upstream at Nature Heights Drive, recent tree management by city crews.

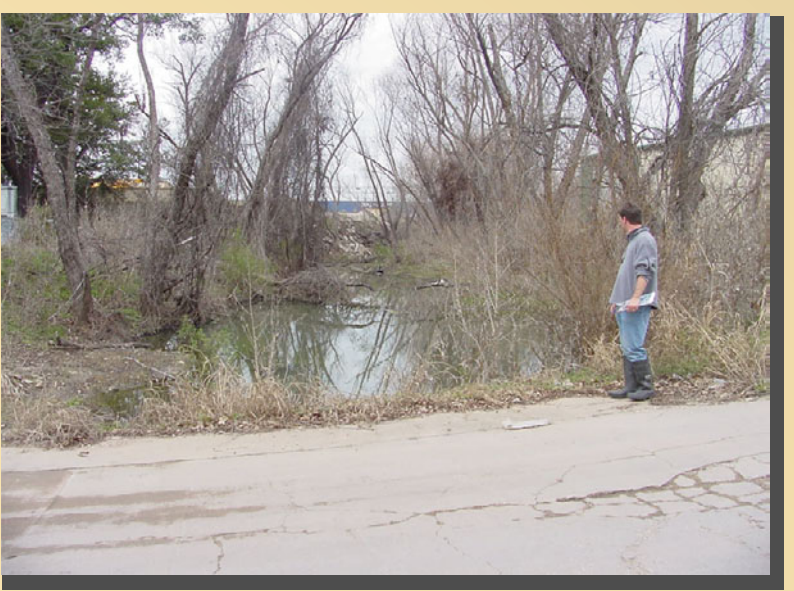
Photo 37. Looking upstream of Commerce Street, disturbed channel below sand & gravel operation, milky water, trash and debris.

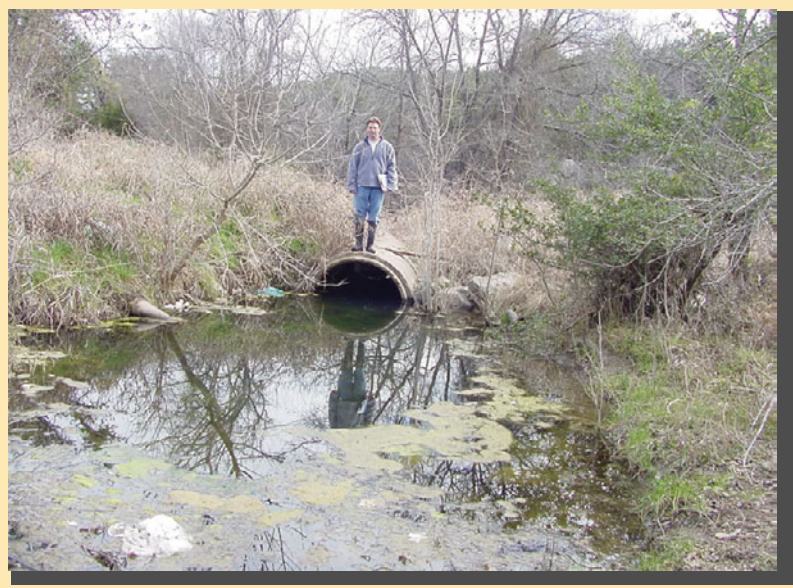
Photo 29. Looking downstream at culvert across creek, notice trash and algae, flow is impeded.

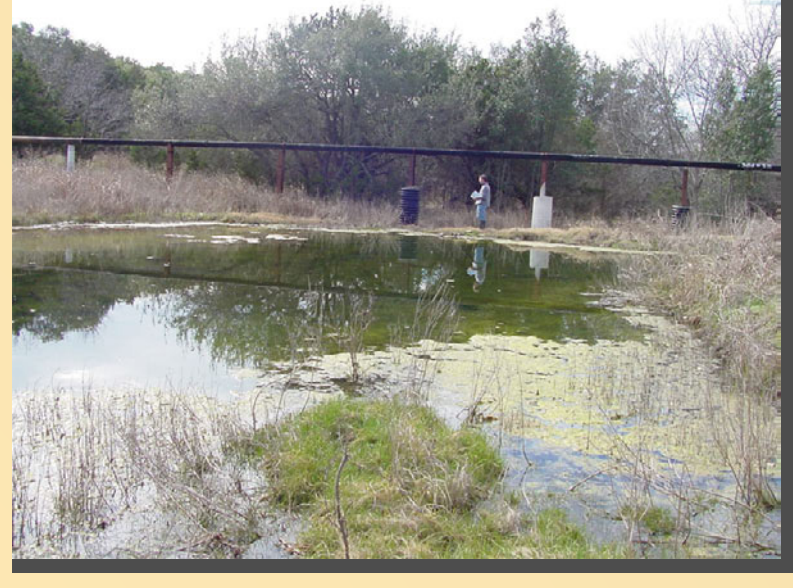
Photo 31. Extension of Bridget Lane, looking downstream at elevated wastewater line above creek, crossing is creating a pond.

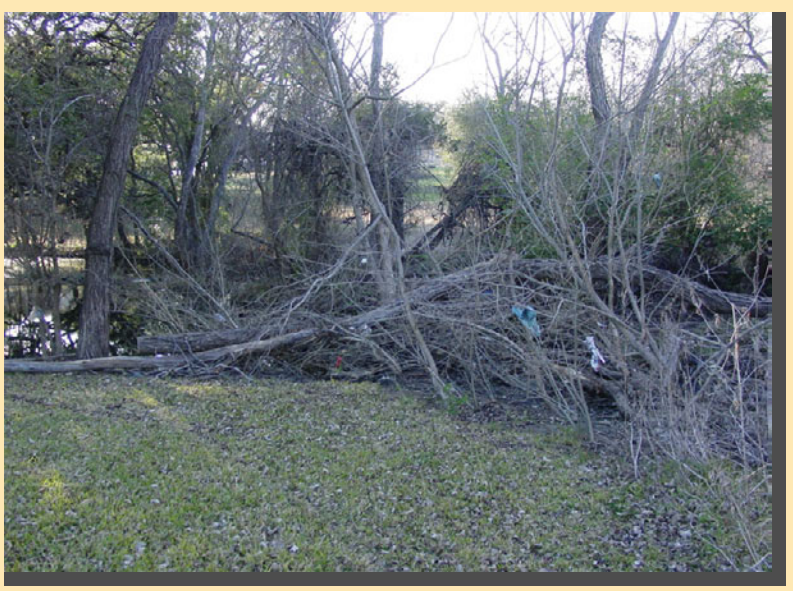
Photo 22. Behind day care center along U.S. 281. Logjam and debris.

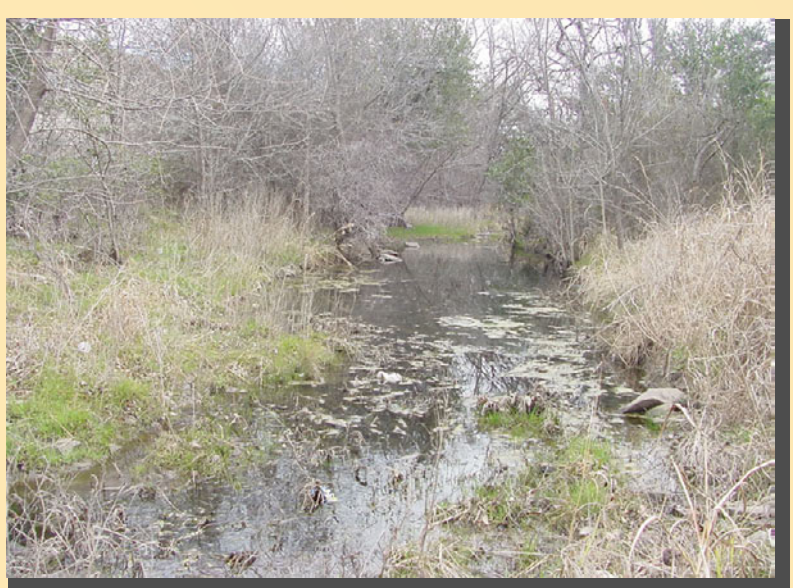
Photo 26. Highway 281, looking upstream, much less trash, more natural appearance, deer tracks, excellent hike/nature trail potential.

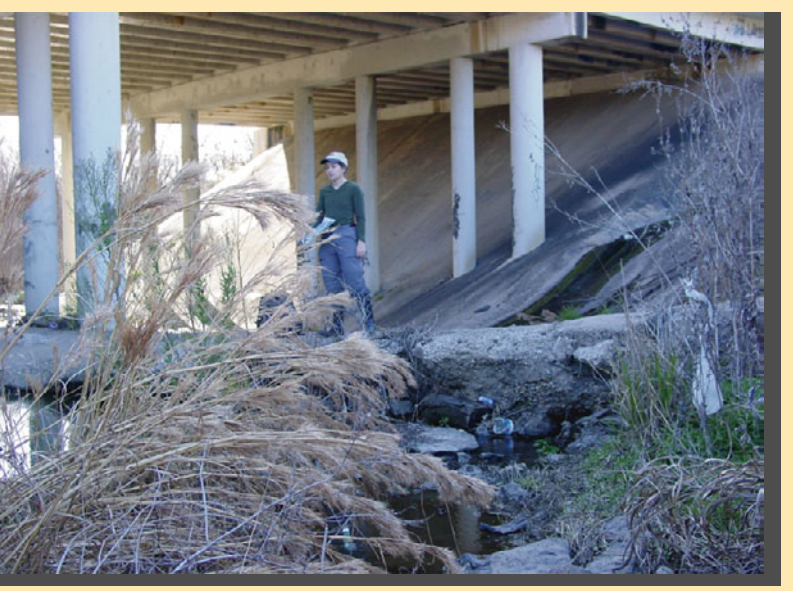
Photo 16. FM 1431 Bridge, upstream side, exposed wastewater line in concrete encasement, creek has scoured below the wastewater line.

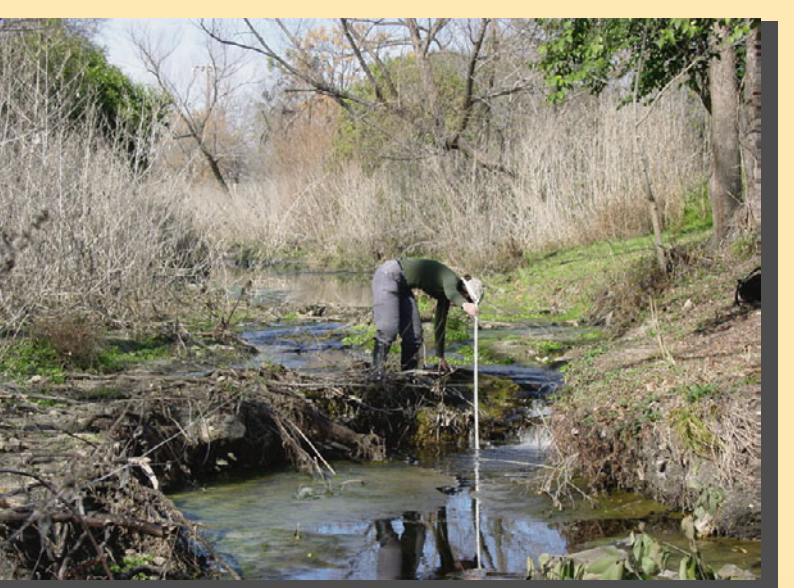
Photo 11. Childress Park, headcut of about 3 feet migrating upstream. Black water with smell of sewage. Algae dominates water surface and creek bottom.

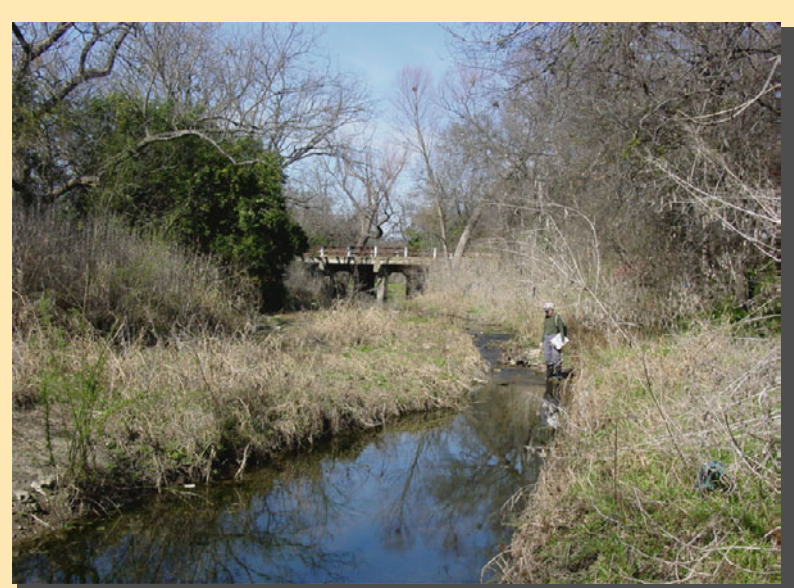
Photo 7. Looking upstream at Third Street, trash on right bank.

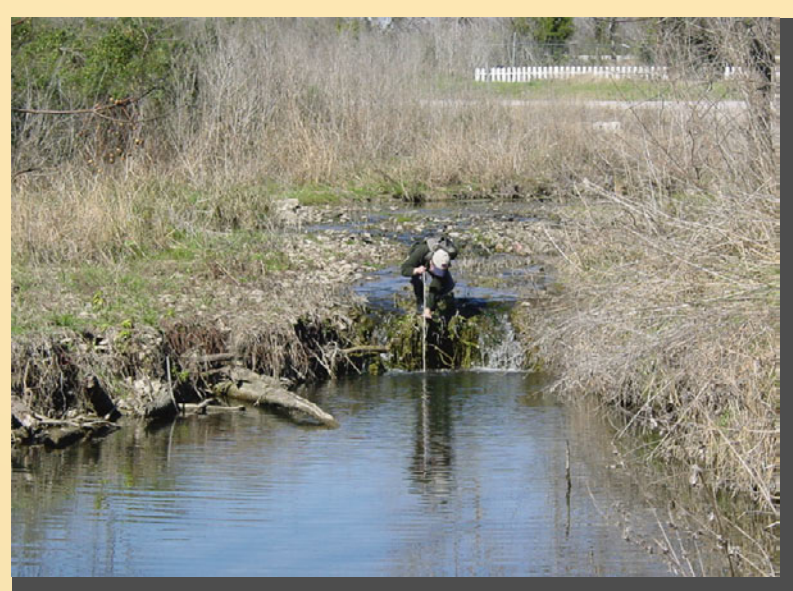
Photo 2. Headcut of about 4.5 feet. Headcut migrating upstream.
