# Wilbarger Creek Watershed

## WILBARGER CREEK WATERSHED FACTS

Wilbarger Creek Watershed  
Travis and Bastrop Counties, Texas

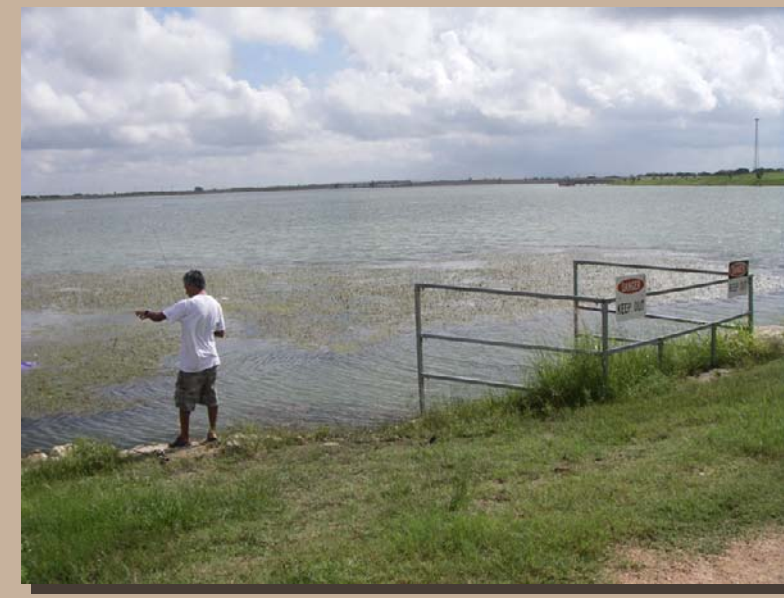
Photo 1. Lake Pflugerville, the municipal water supply reservoir, is augmented by water pumped from the Colorado River near Del Valle.

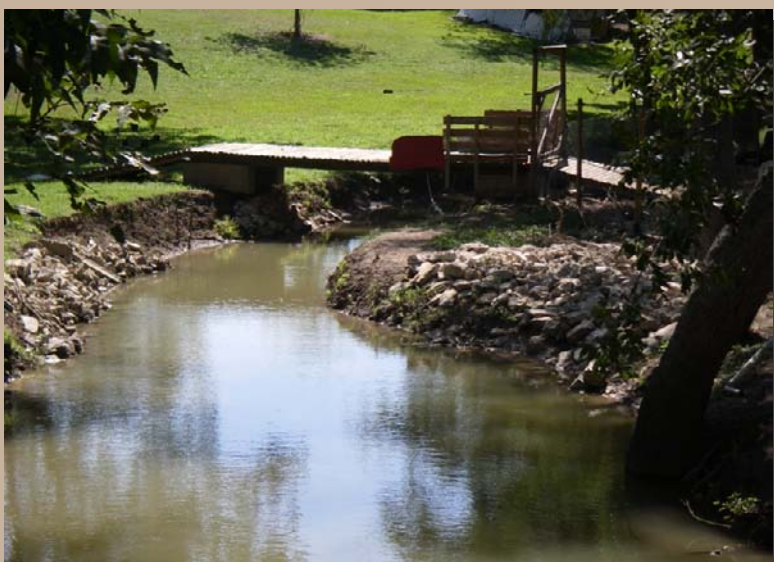
Photo 2. Looking downstream, this view of Wilbarger Creek at Weiss Lane runs through a residence and goat farm.

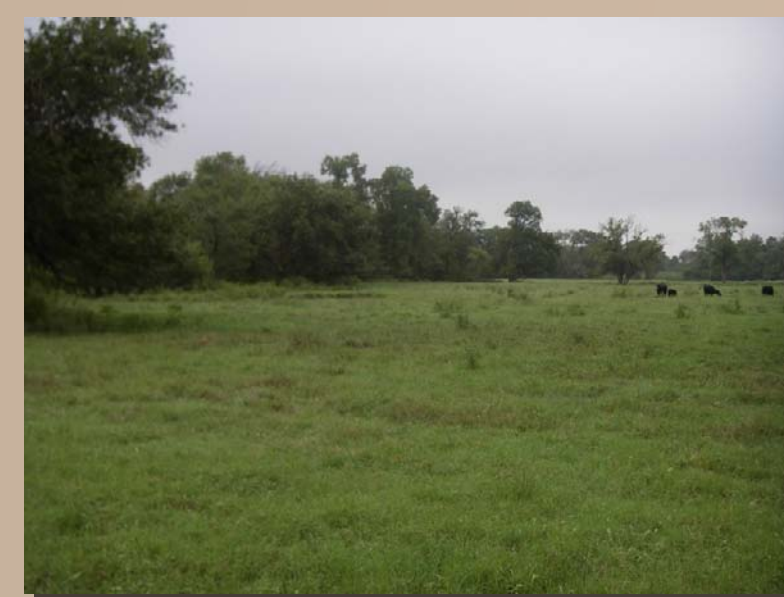
Photo 3. In a downstream view, this riparian pasture on the right bank of Wilbarger Creek at Gregg Lane is the site of a proposed wastewater treatment plant.

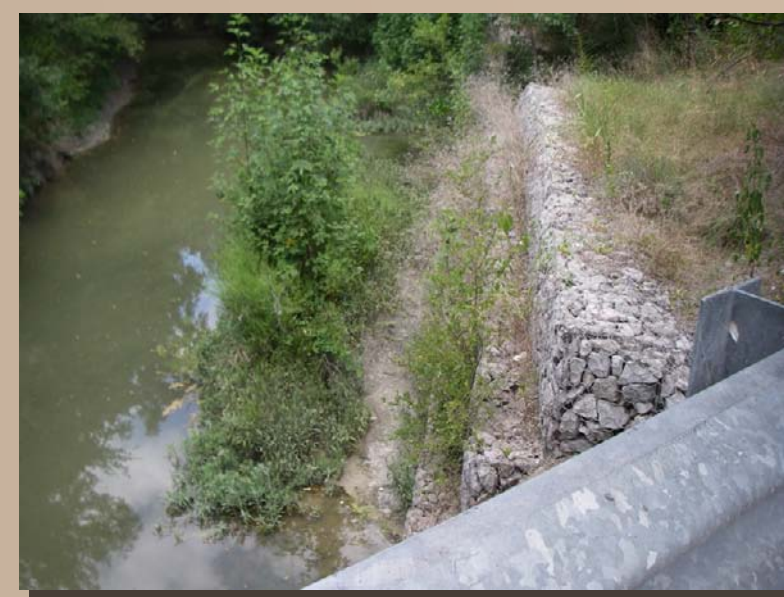
Photo 4. As this upstream view shows, gabion stream bank protection is built along Wilbarger Creek at Jones Road.

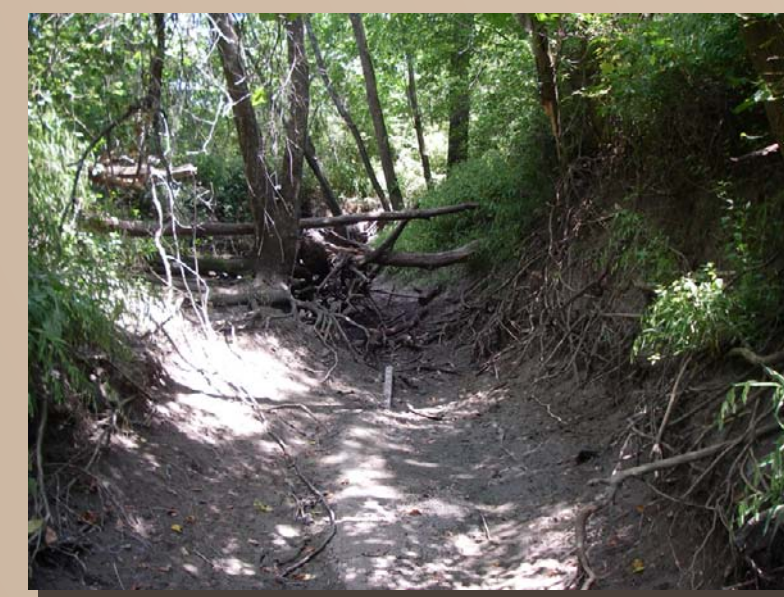
Photo 5. Dry Creek at Little Road has an ephemeral streambed, as this upstream view shows.

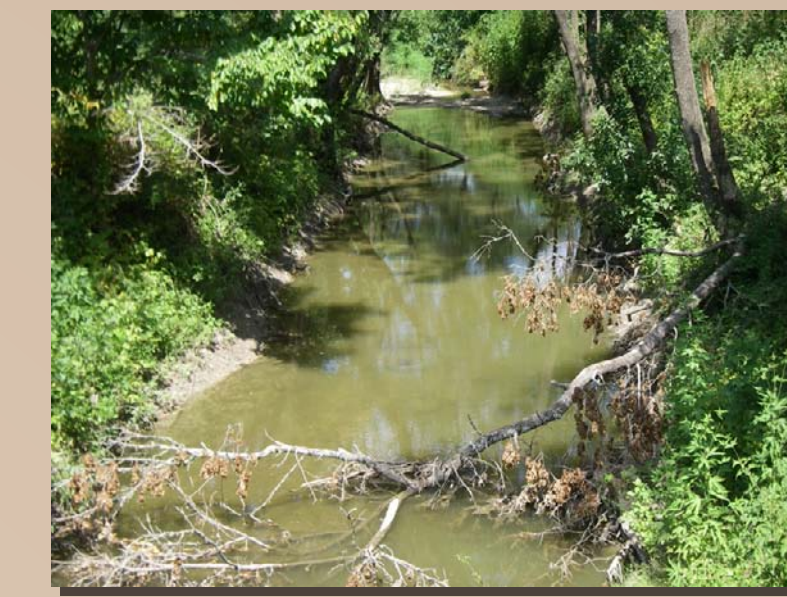
Photo 6. Wilbarger Creek at Biting School Road is an intermittent stream with a wooded riparian buffer, as shown in this upstream view.

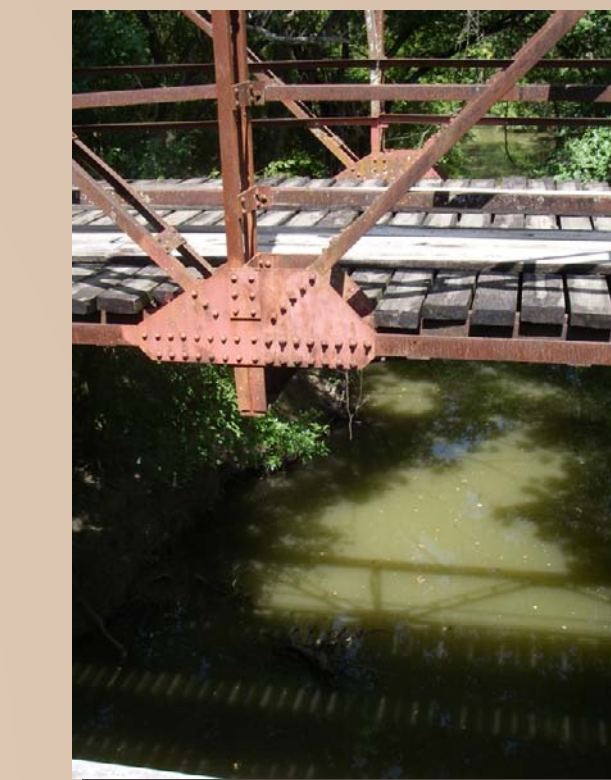
Photo 7. A trellis bridge crosses over a deep stream channel of Wilbarger Creek at Upper Elgin Road. This is a downstream view.

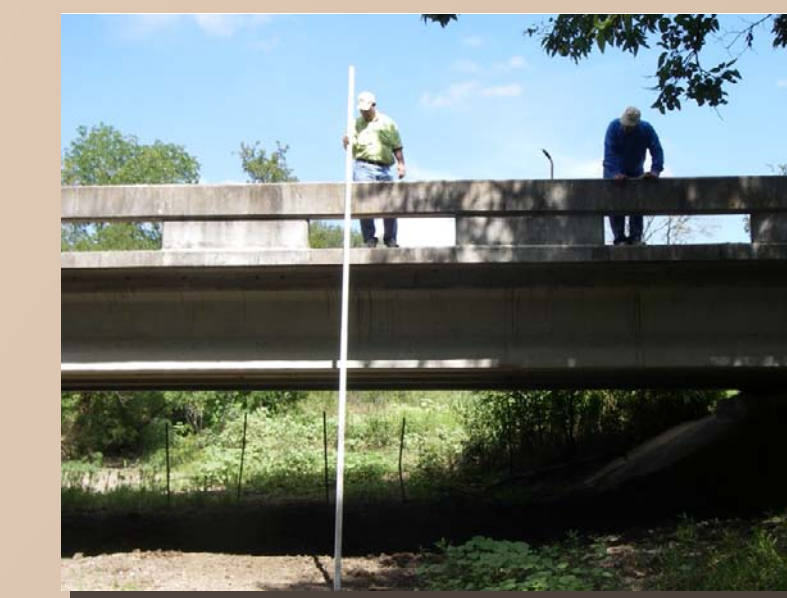
Photo 8. LCRA staff measures stream channel cross-sections at Lower Dry Creek at Upper Elgin Road. This view looks upstream.

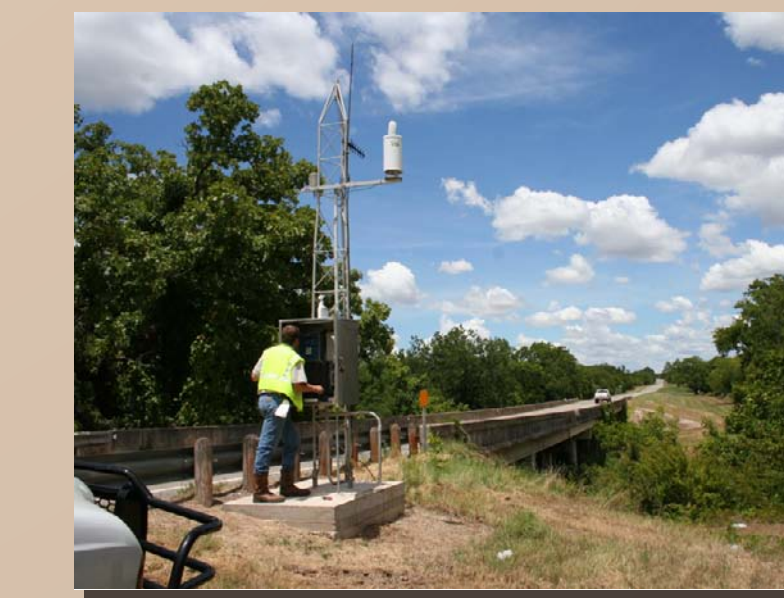
Photo 9. An LCRA Hydromet streamflow gauge is situated on Wilbarger Creek at FM 1704 downstream of Elgin.

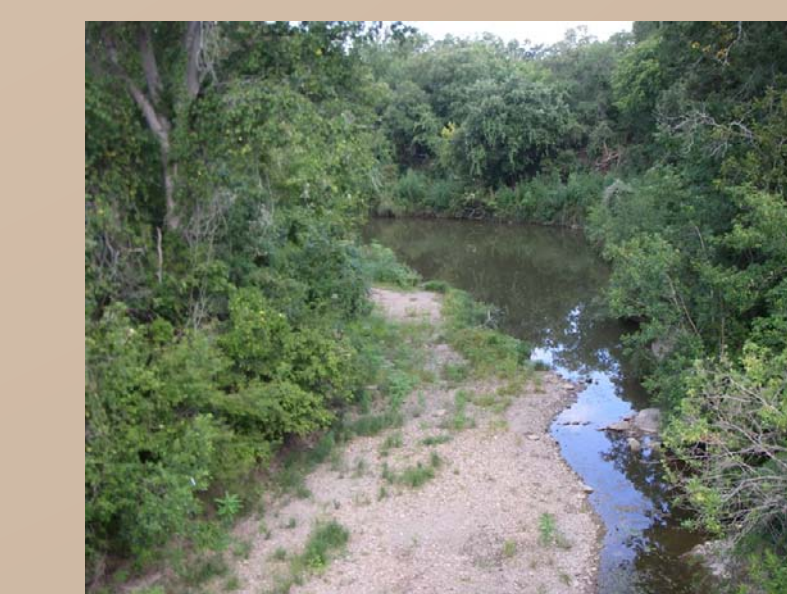
Photo 10. This incised channel of Wilbarger Creek at Lower Elgin Road contains alluvium in its streambed. This is an upstream view.

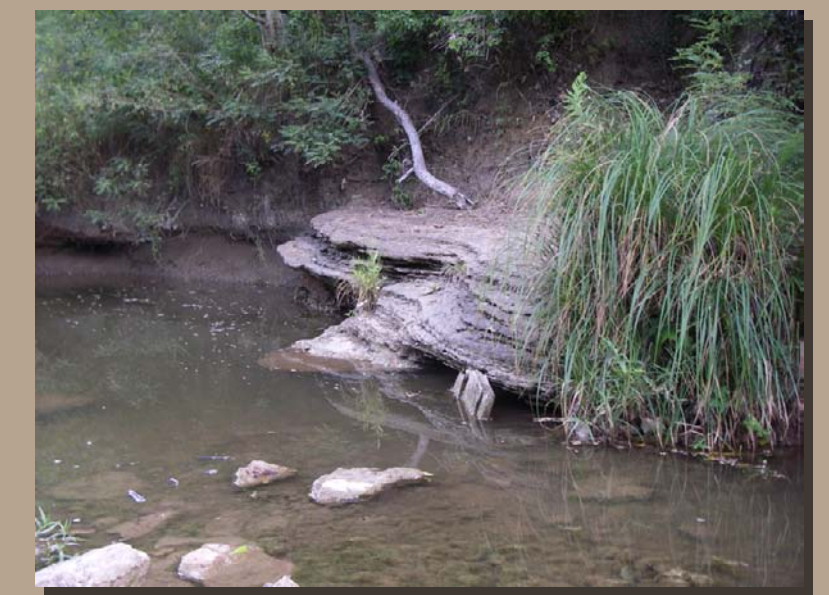
The bank of Wilbarger Creek at Lower Elgin Road has an outcrop of Hooper mudstone formation.

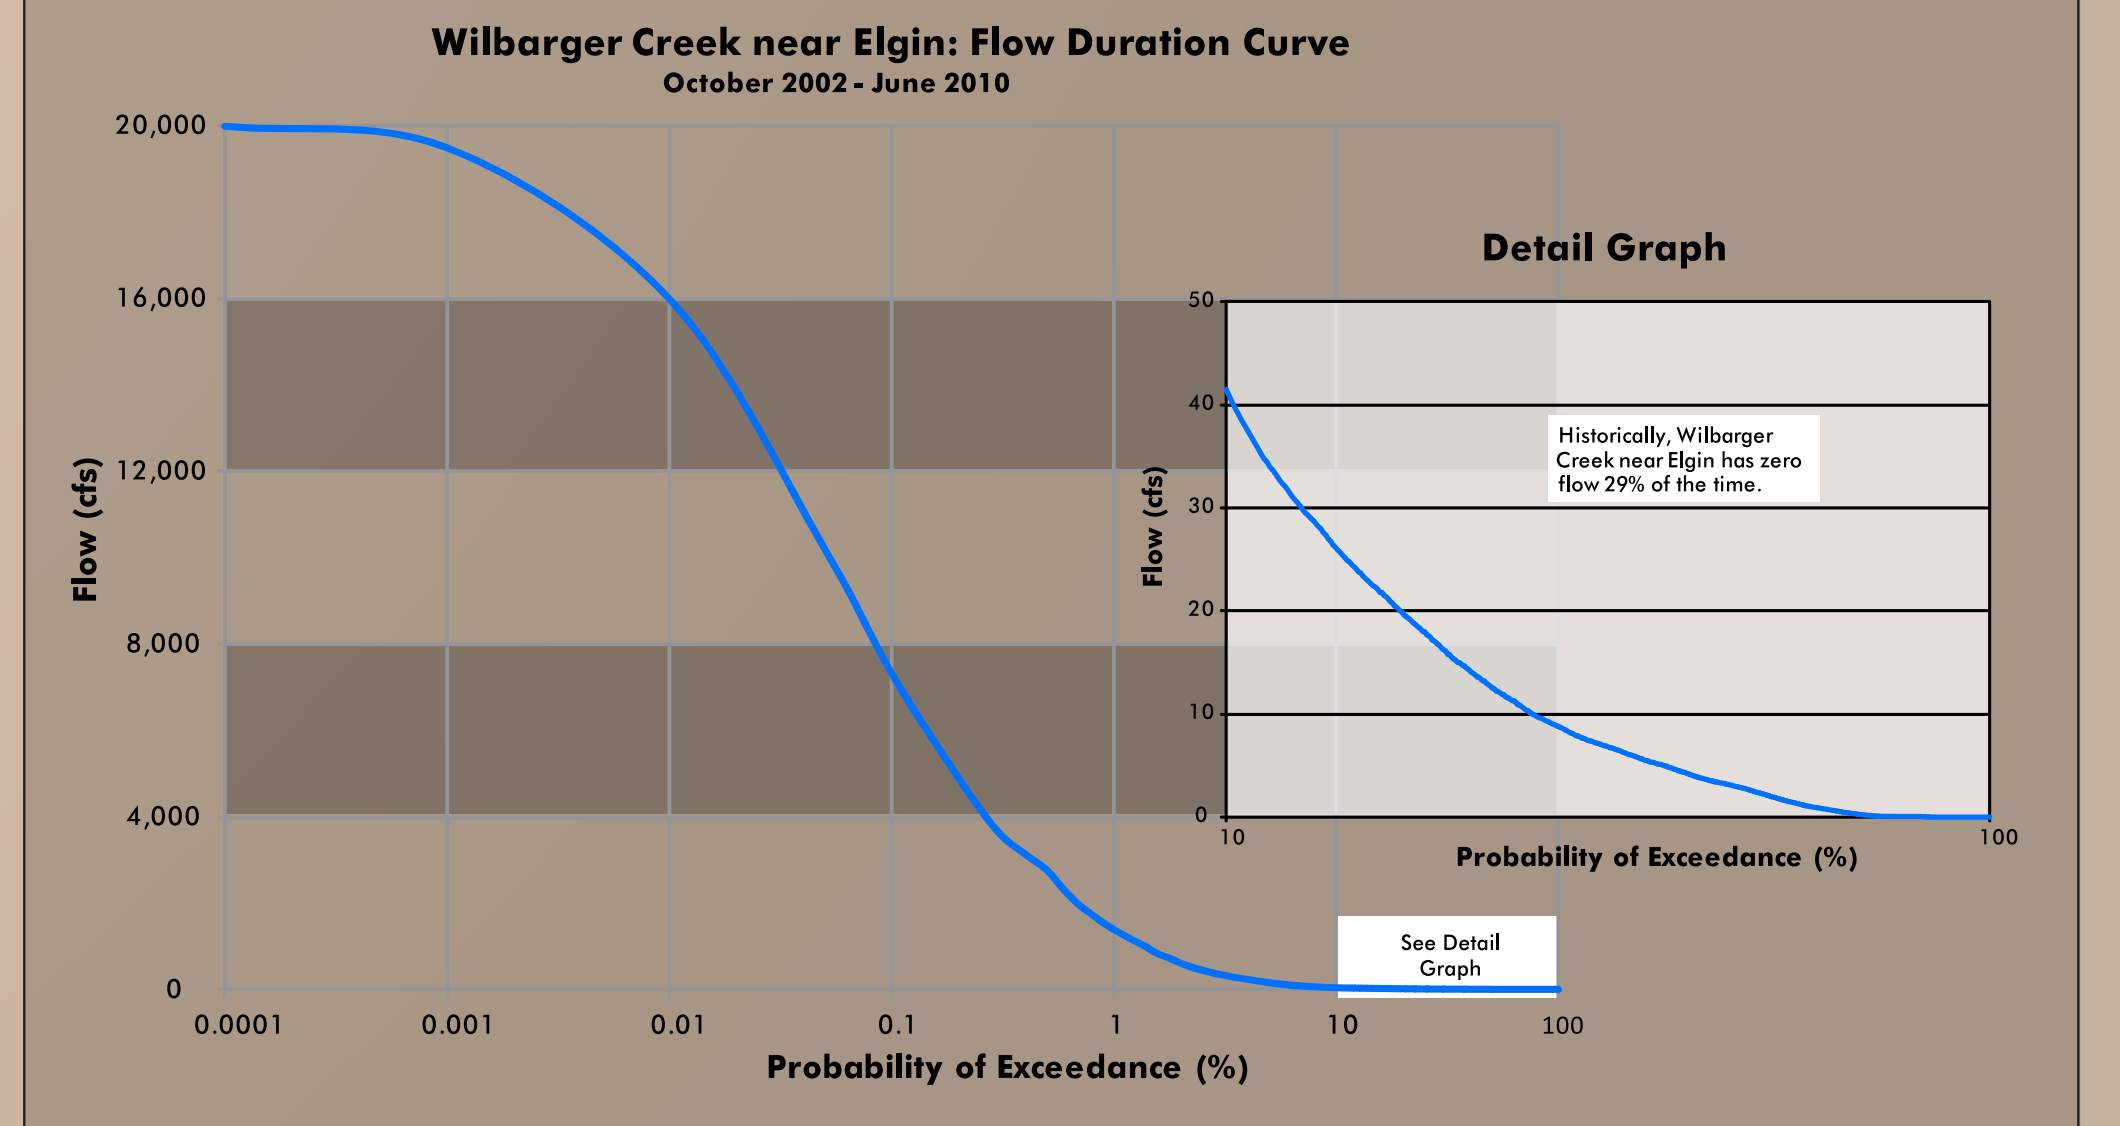
## Flow Duration Curve

This chart shows percent of the time that any rate of stream flow is equaled or exceeded. The flow duration curve for Wilbarger Creek is based on 8 years of records collected every 15 minutes and reflects more than 27,000 data points. The highest recorded flow rate was 20,000 cubic feet per second (cfs) on January 13, 2007. Of interest for this study, the flow exceeded zero 71 percent of the time. In other words, Wilbarger Creek at FM 1704 near Elgin has zero flow 29 percent of the time. In its natural condition, Wilbarger Creek is an intermittent stream. With significant and constant contribution of wastewater discharge, Wilbarger Creek will become a perennial stream with measurable baseflow. Water quality at times of low flow will depend on quality of the wastewater effluent.
